# Manhole Inspection Summary

Manhole # S07GG2005MH

Insp Date: **7/18/06 7:26 AM**

**Location** Address: **6122 GREENSPRING AVE**

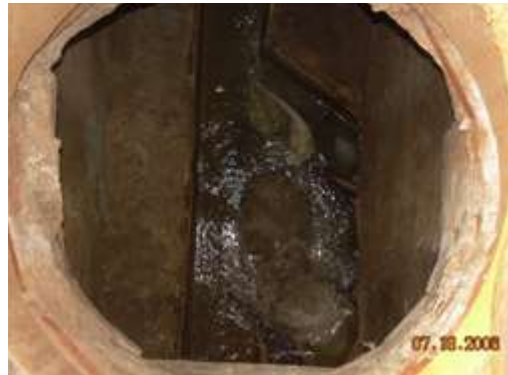
Top View

Frame leaks. Adjustment deterioration and infiltration. Barrel infiltration. Evidence of surcharge - Bench debris. Channel

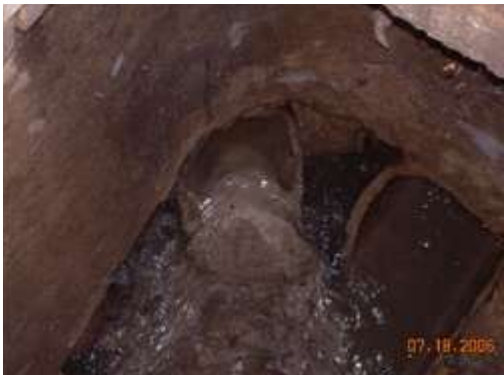
Defect

Adjustment and Barrel infiltration. Channel debris. Missing step. Bench and Channel deterioration.

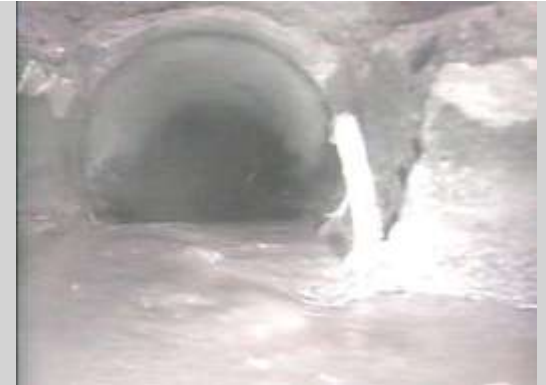
### 10 in. Circular Gravity Sewer Pipe Out @ 12 O'Clock

Infiltration: **Evidence** Pipe Seal Cond: **Unknown**

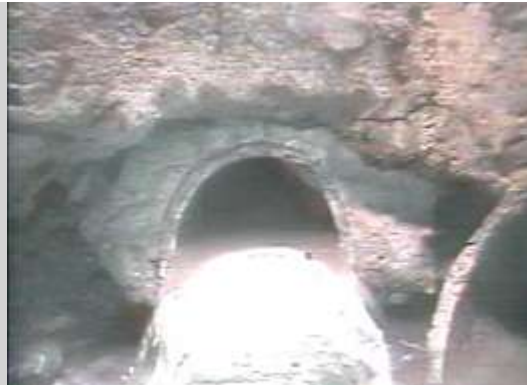
### 8 in. Circular Gravity Sewer

Barrel deterioration, cracks and infiltration.  
Bench deterioration.

Deposits: ☐ None ☐ Mud ☐ Sludge ☒ **Debris** ☐ Grease

Silt Depth: **3** (in.) Deposits Extent: **Heavy**

Infiltration: **Evidence** Pipe Seal Cond: **Cracked**
